CONNECTICUT RIVER BASIN
MIDDLETOWN, CONNECTICUT

UPPER MILL POND DAM
CT 00141

January, 1981

PHASE I INSPECTION REPORT

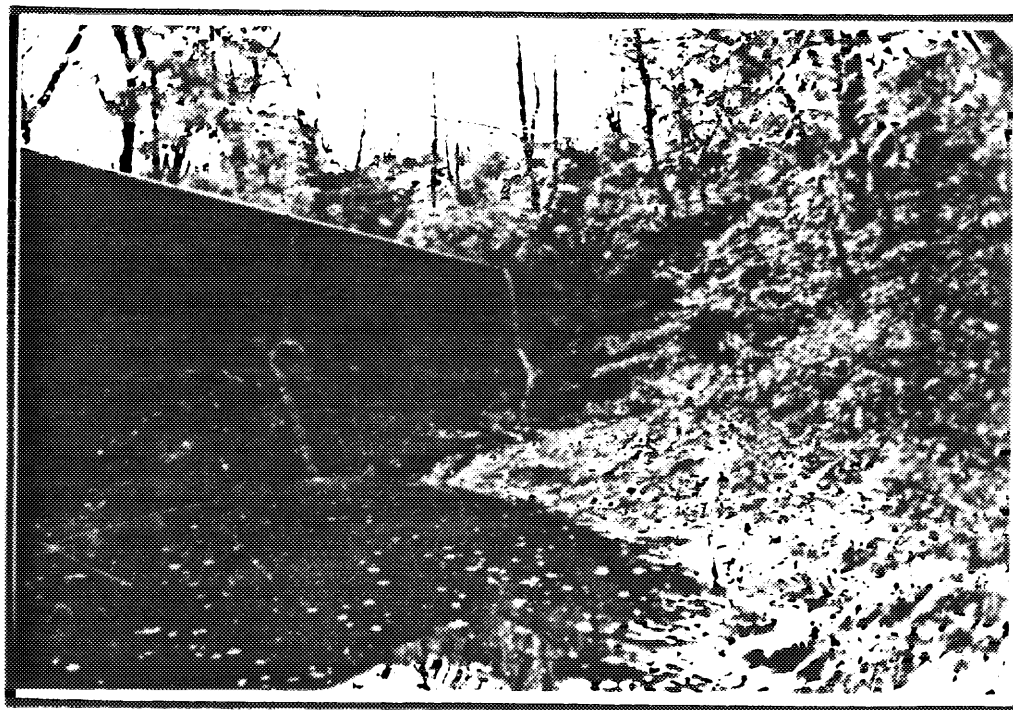
moss and weeds are growing from the joints. The spillway weir and east abutment are in good condition. The west abutment is badly spalled at its base. The discharge gate inlet structure is badly spalled and the bar rack is cluttered with debris. There is some seepage at the east end of the dam where the stone masonry meets the abutment/ledge interface. Vegetation is growing around this area as well. The ledge continues along the downstream channel bank and there is minor seepage.

WEST ABUTMENT

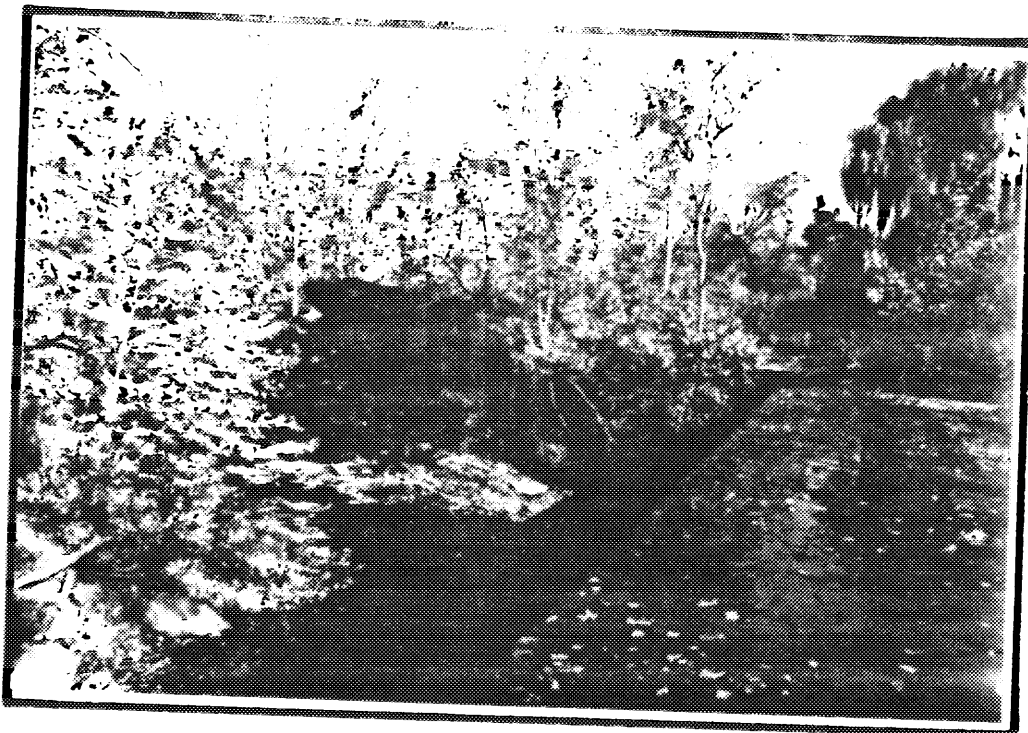
SPILLWAY - EAST ABUTMENT

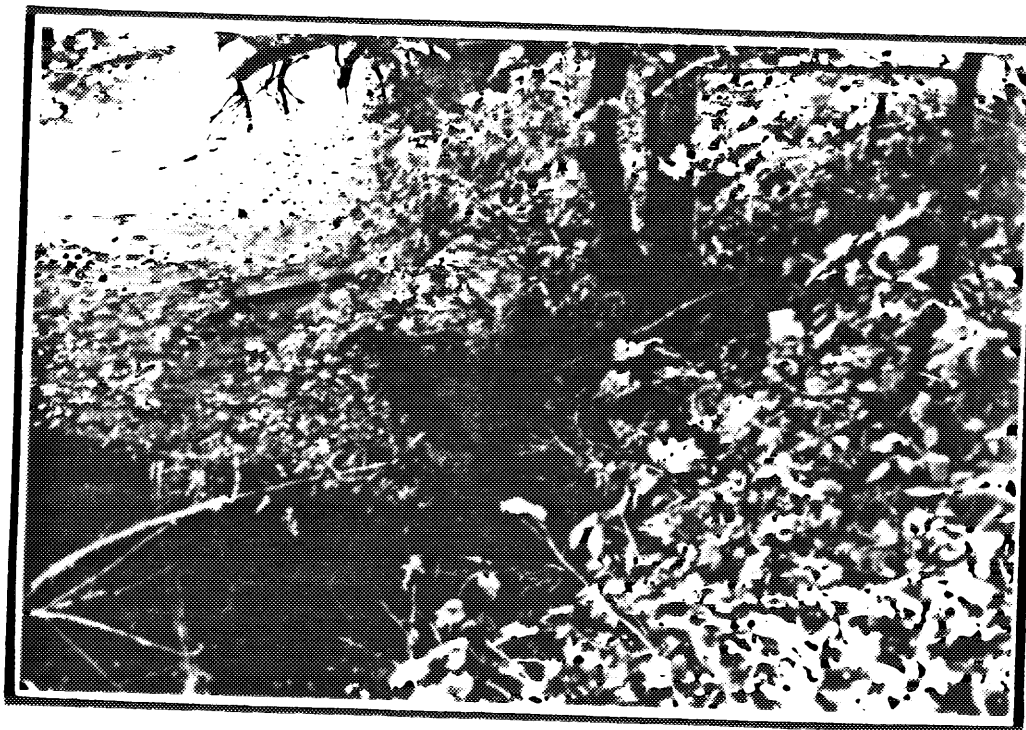
TRAINING WALL - WEST ABUTMENT

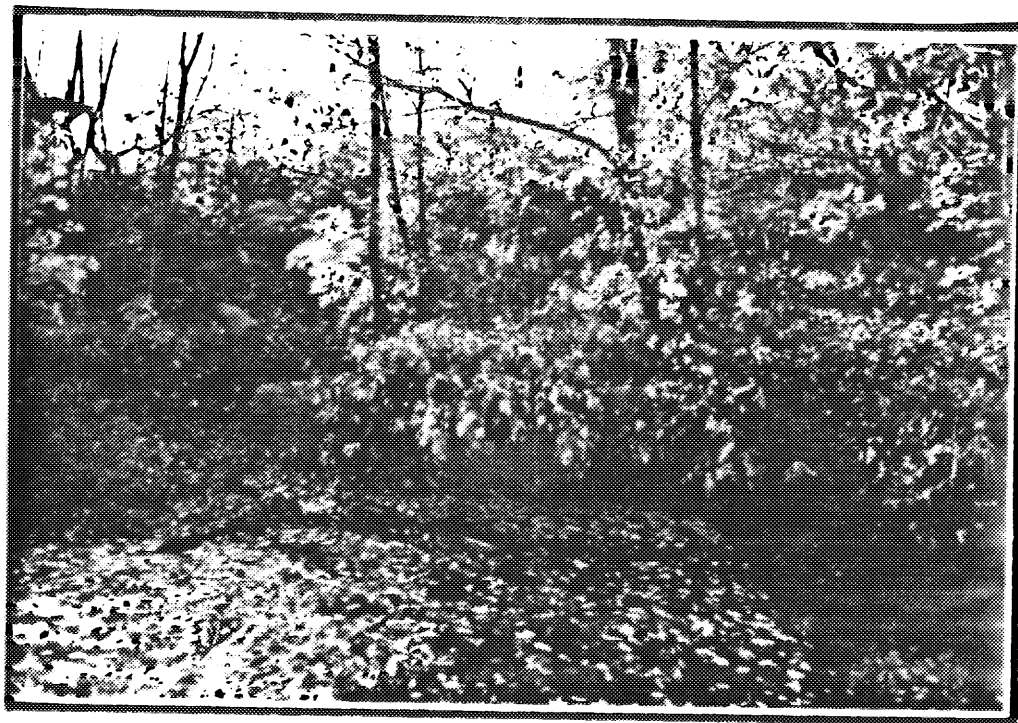
A drainage pipe outlets above the west abutment. There is presently a scour hole at this location. This scour hole has caused the last section of the drainage pipe to collapse into the hole and is undermining the west spillway abutment.

TRAINING WALL - WEST ABUTMENT - DRAINAGE PIPE

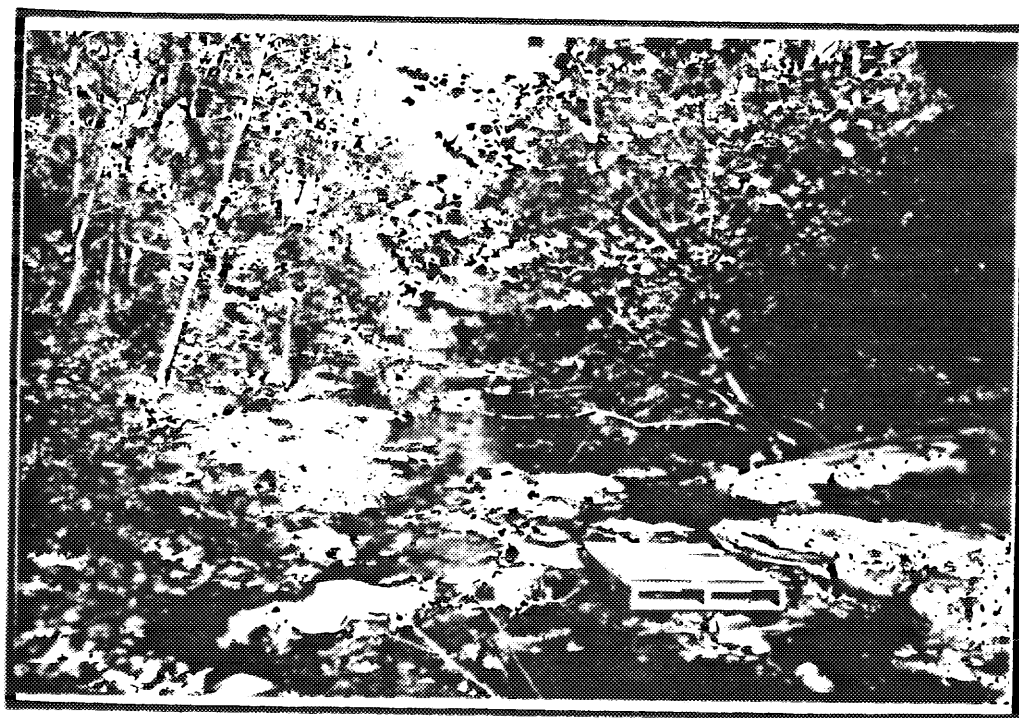
DOWNSTREAM CHANNEL
